**HIGHWAY  
RESEARCH**

**341**

Aggregates and  
Skid Resistance of  
Bituminous Pavements

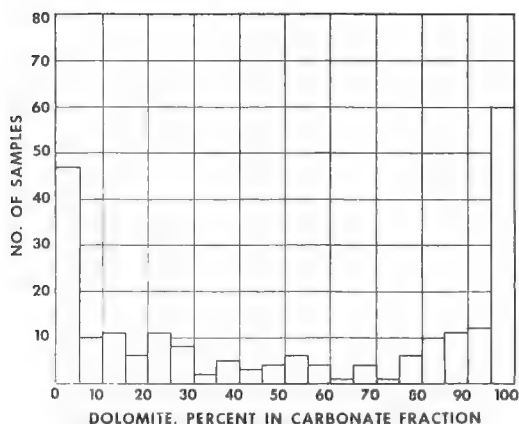
Figure 2. Distribution of carbonate compositions of 224 test samples.

to Mississippian. Figures 2 and 3 show the general composition of carbonate aggregates quarried in the state (10). Individual rock samples tend to be either predominantly calcite or predominantly dolomite rather than mixtures of the 2 minerals (Fig. 2). For example, of the 224 samples processed, 47 were predominantly calcite and contained less than 5 percent dolomite, while 60 were predominantly dolomite and contained less than 5 percent calcite. The range of insoluble residues for the same group of 224 samples is shown in Figure 3. Clearly, limestone aggregates produced in Virginia tend to contain low percentages of insolubles, with more than 50 percent of the samples falling in the interval between 0 and 10 percent. On the other hand, the 3 highly impure limestones considered by Gray and Renninger (4) as having excellent skid-resistance properties contained from 36 to 48 percent insolubles. It would appear that these kinds of rocks are typical of the vast majority of Virginia limestone aggregates (Fig. 3).

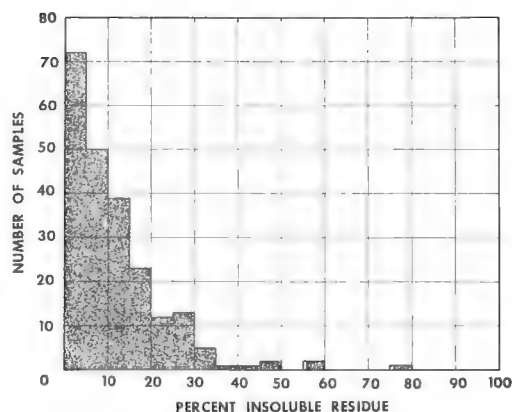
Figure 3. Distribution of insoluble residues determined for 224 test samples.

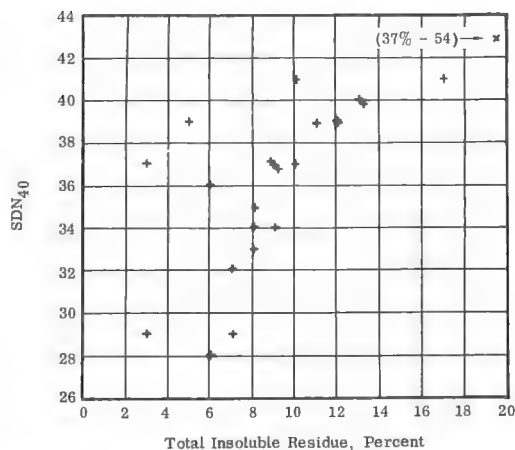
Figure 4. Effect of insoluble residue on polish resistance.

of this relationship, Figure 4 was constructed by plotting coefficient of friction versus insoluble residue for each quarry source. A fairly well-defined curvilinear relationship, similar to that obtained by Burnett et al. (1) for insolubles coarser than 200 mesh, is evident. It is thought that more detailed sampling and insoluble residue measurement for these and other limestone sources will clarify this relationship.

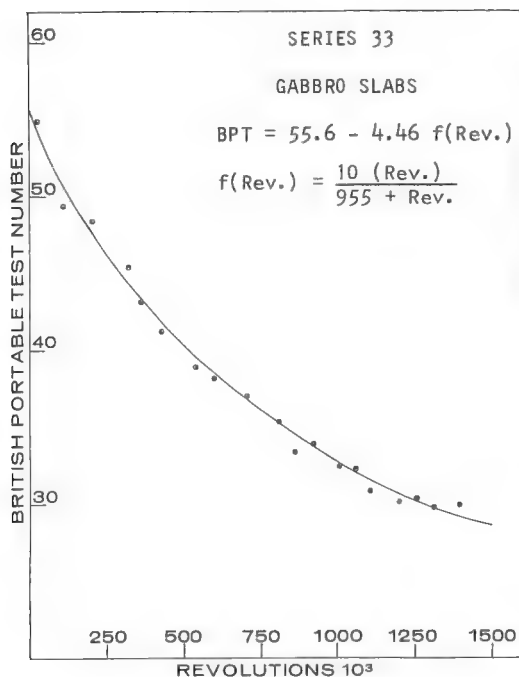
Figure 2.

Figure 2 shows the data from the tests of this set of slab samples on a normal linear plot of BPT versus revolutions. In Figure 3, the same data are shown and the hyperbolic function is used for the revolutions scale. The linearizing effect of the transformation of the data can readily be seen.

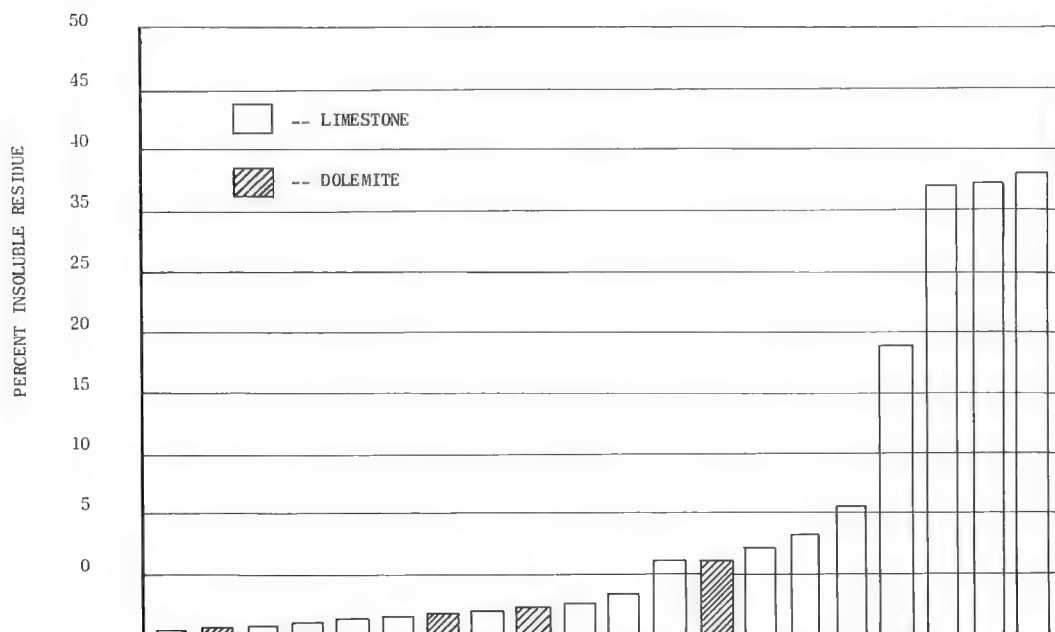
Figure 2. Percentage of insoluble residue of +200 sieve size on test strips 1 through 11.

Insoluble residue tests were run on a cross section of carbonate aggregates produced from rock from various geologic areas in Pennsylvania. This permitted a selection of 20 carbonate aggregates, including limestones and dolomites with insoluble residues ranging from less than 1 percent to more than 35 percent as shown in Figure 2.

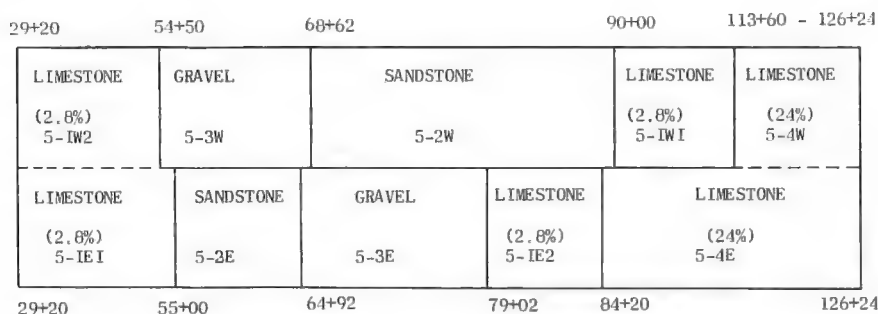
Figure 3. Plan of test strip 5.

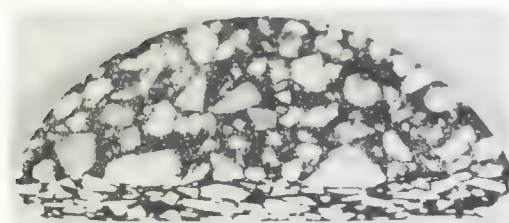
Figure 3. Pavement core showing aggregate particles in oily polished surface.

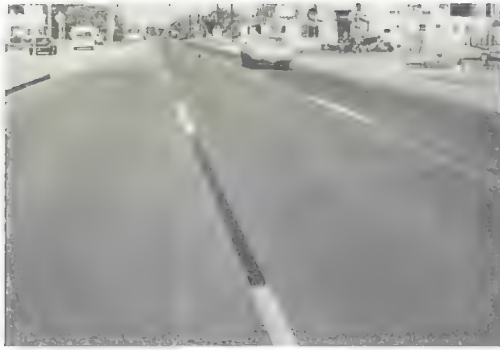
Figure 4. Crushed sandstone surface 4 years after construction.

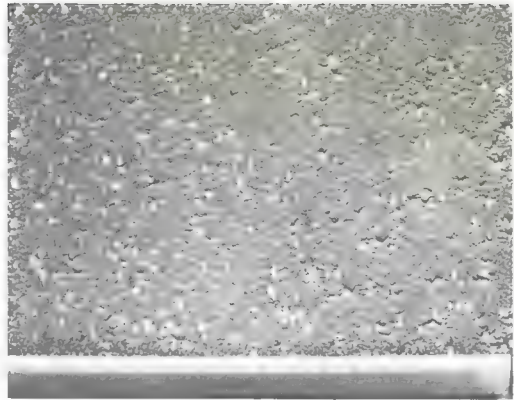
Figure 5. Close-up of sandstone surface 4 years after construction.

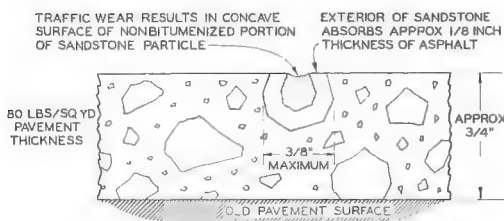
Figure 6. Result of traffic wear on larger particles of crushed sandstone.

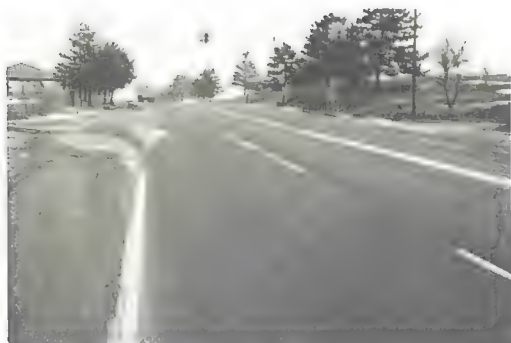
Figure 7. Crushed quartzite surface 3 years after construction.

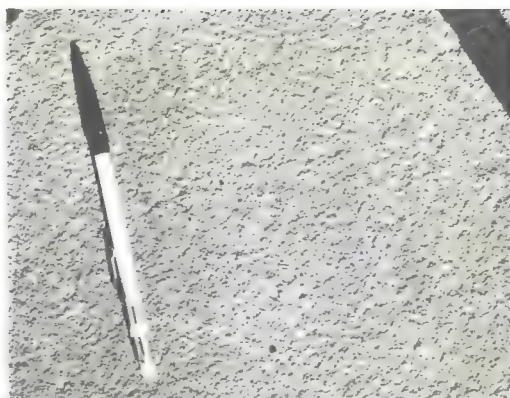
Figure 8. Close-up of quartzite surface 4 years after construction.

percent 60 to 70 asphalt; 4.0 percent fly ash was added as mineral filler to make up for the fines lost through washing, and the remainder was quartzite crushings. No other aggregate was added for this mix design. Figure 7 shows a typical surface after 3 years of service in the Flint area. Some loss was experienced where traffic entered from a side gravel road causing considerable localized abrasion; however, the rest of the surface is in good condition. Figure 8 shows a close-up of this excellent skid-resistant surface.

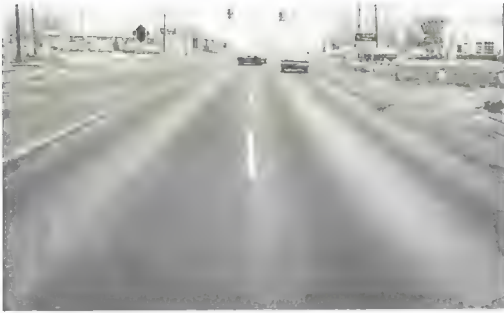
Figure 9. Crushed beach pebbles 3 years after construction.

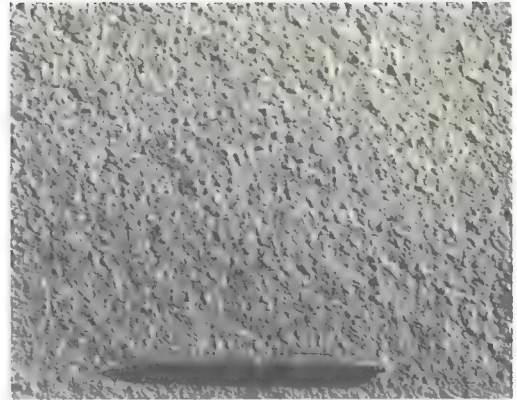
Figure 10. Close-up of beach-pebble surface 4 years after construction.

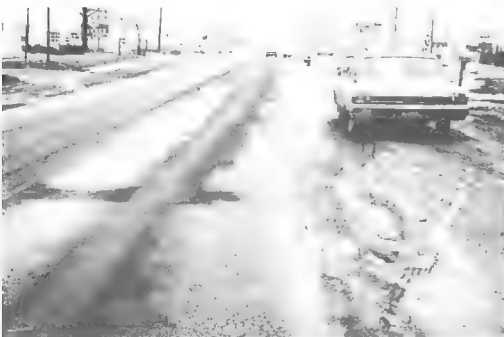
Figure 11. Crushed traprock 3 years after construction.

The mix design called for 6.1 percent 60 to 70 asphalt plus 3.5 percent added fly ash mineral filler; the remainder was crushed traprock. No other aggregate was added to this mixture, which was used at an intersection south of Flint. Figure 11 shows the

surface after 3 years of service. Considerable areas of the surface were worn completely through to the old pavement. No detour provisions were made, and heavy traffic was permitted to traverse the uncured, warm mat, resulting in premature wear that was evident within a few days after construction. I believe this mix would have proved more durable if traffic had not been permitted on the warm surface during construction.

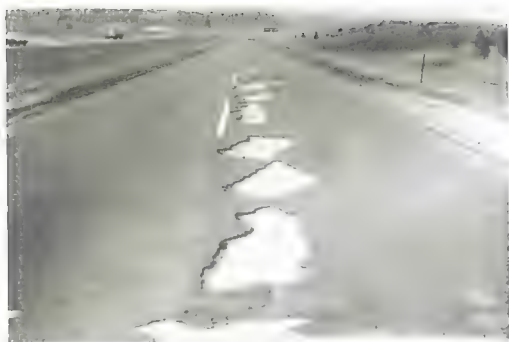
Figure 12. Synthetic bitumen and sand 1 year after construction.

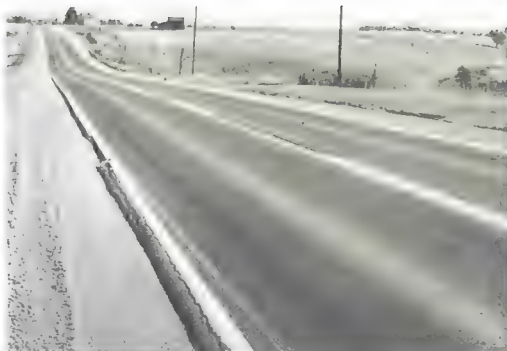
Figure 13. Sand-emulsion surface 4 years after construction.

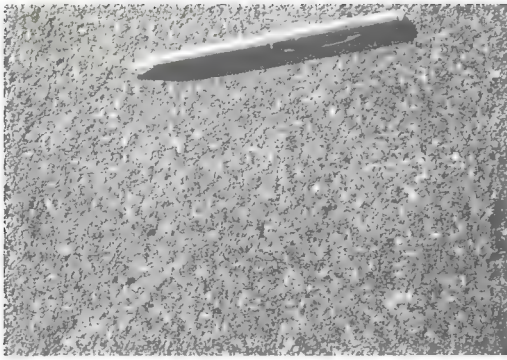
Figure 14. Close-up of sand-emulsion surface 4 years after construction.

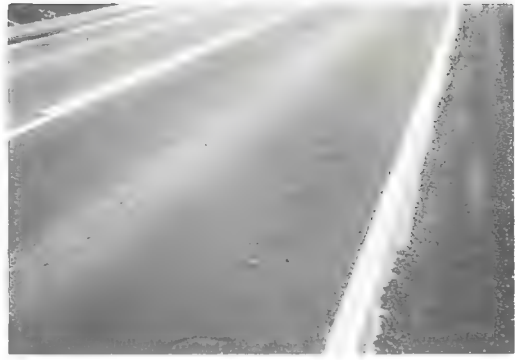
Figure 15. Delamination of sand-asphalt surface 1 year after construction.

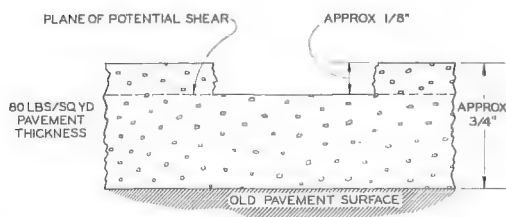
Figure 16. Cross section of delaminated sand-asphalt surface.

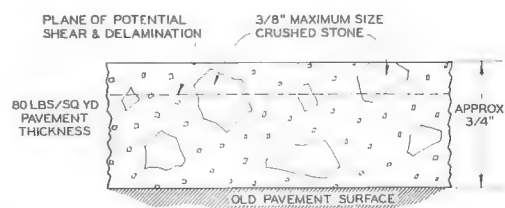
Figure 17. Cross section of stone-filled sand-asphalt surface.

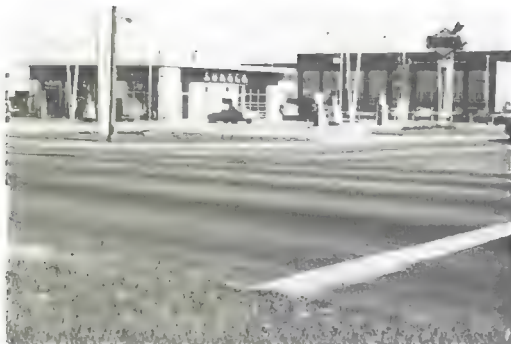
Figure 18. Stone-filled sand-asphalt surface 4 years after construction.

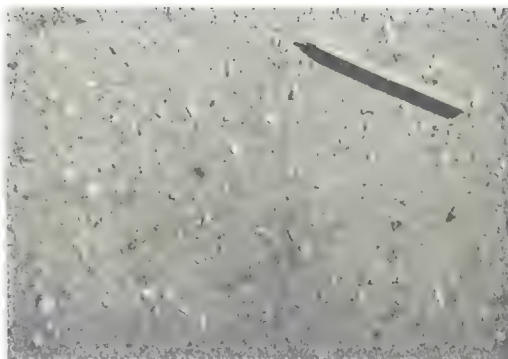
Figure 19. Close-up showing stones sticking out of stone-filled sand asphalt.

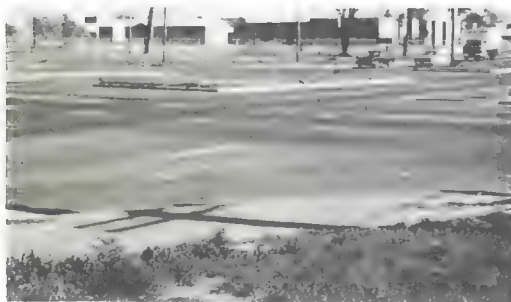
Figure 20. Raveled fillets of sand-asbestos surface 4 years after construction.

Figure 20 shows a typical area in Detroit after 4 years of service. It is generally in good condition except for the fillet areas that were manually placed and cooled before

they were properly compacted, resulting in some raveling. Figure 21 shows a close-up of the sand-asbestos-asphalt surface texture that exhibits satisfactory skid resistance.

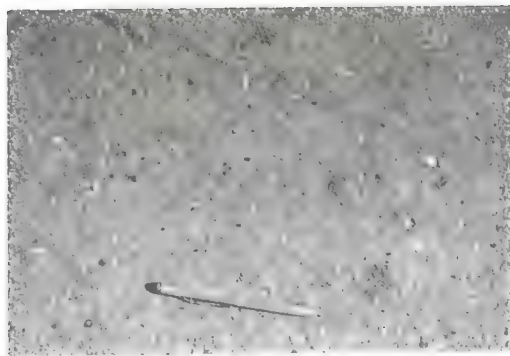
Figure 21. Close-up of sand-asbestos surface 4 years after construction.

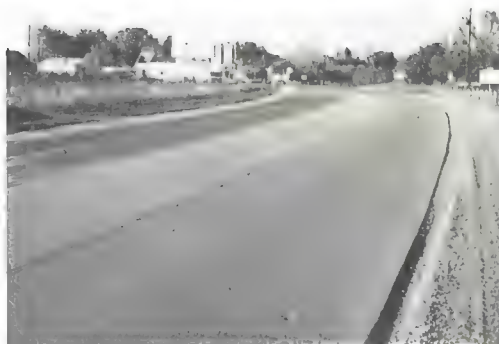
Figure 22. Sinopal-sand surface 4 years after construction.

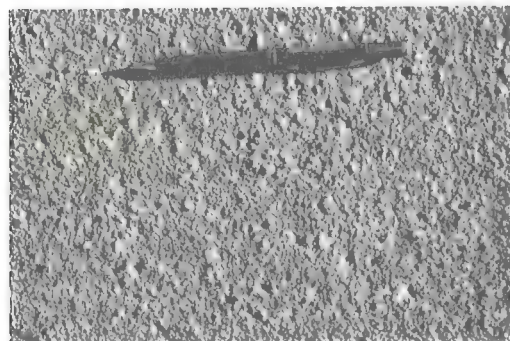
Figure 23. Close-up of Sinopal-sand surface 4 years after construction.

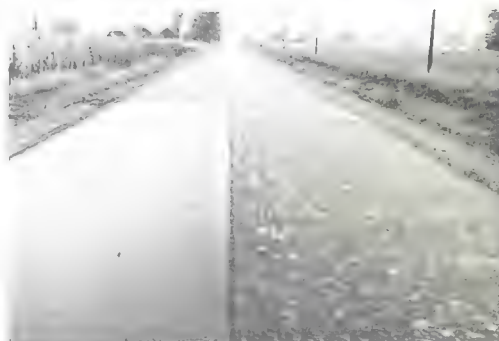
Figure 24. Freshly laid bituminous surface after rain.

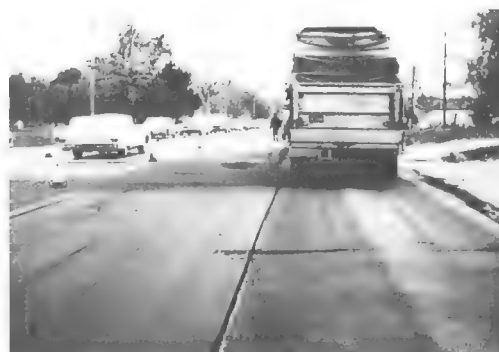
Figure 26. Spreading precoated sand on unrolled bituminous mat.

initial skid-resistant bituminous surface by applying hot sand, precoated with about 1 percent asphalt cement, on the unrolled mat behind the paver. This is then rolled into the surface and reduces the initial slickness. About 2 to 5 lb/sq yd of this precoated sand is sufficient; more may produce a ball-bearing effect, which can also be dangerous and may mar the pavement surface when bunched-up sand is rolled into the mat.

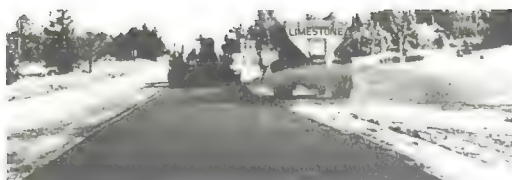
Figure 27. Spreading precoated sand without deflector (most of sand falls on shoulder).

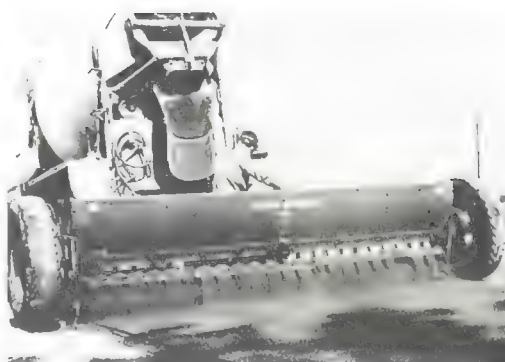
Figure 28. Seeder used for spreading precoated sand leaves ridges.

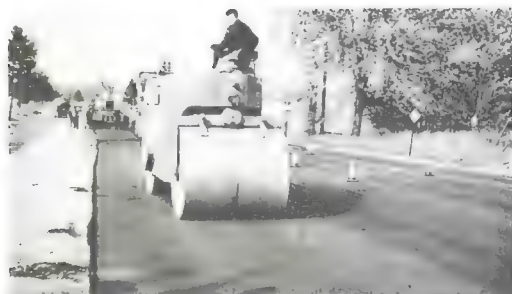
Figure 29. Rolling pavement after sand application.

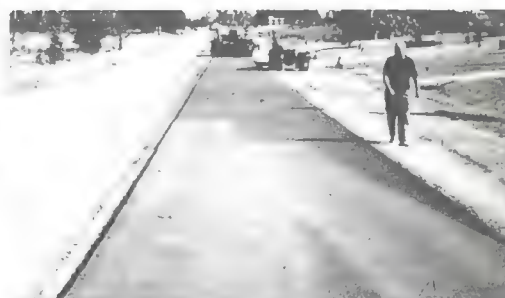
Figure 30. Precoated sand on mat of partly rolled surface.

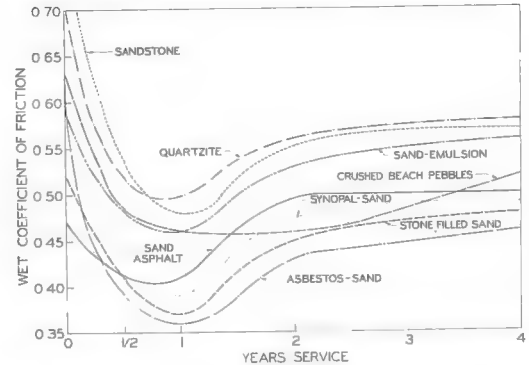
Figure 31. Pavement skid-resistance coefficients of different materials versus years of service.

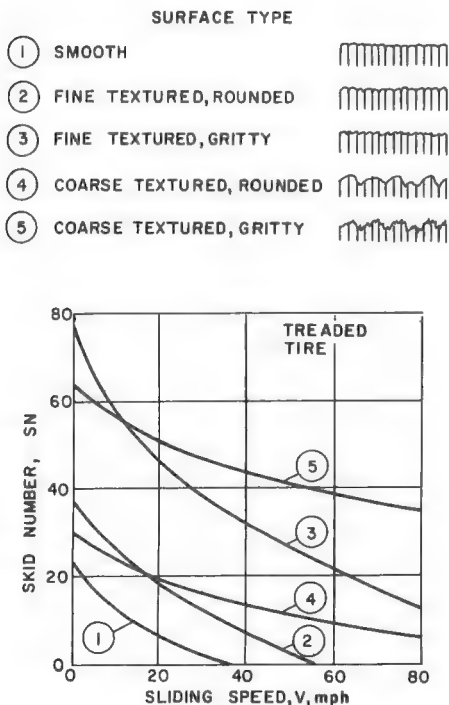
Figure 1. Classification of pavement surfaces according to their friction and drainage properties (13).

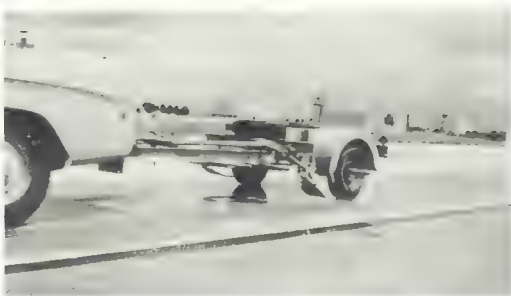
Figure 2. Texas Highway Department research skid trailer.

The friction measurements reported here were obtained with the Texas Highway Department research skid trailer that conforms substantially to ASTM standards and utilizes E-17 treaded tires inflated to 24 psi. The drag forces were measured with strain gages, and the self-watering system utilized a centrifugal pump that applied a water film approximately 0.020 in. in thickness to the pavement surface. The development and calibration of the trailer may be reviewed in an earlier research report (14). Figure 2 shows the trailer under test conditions.

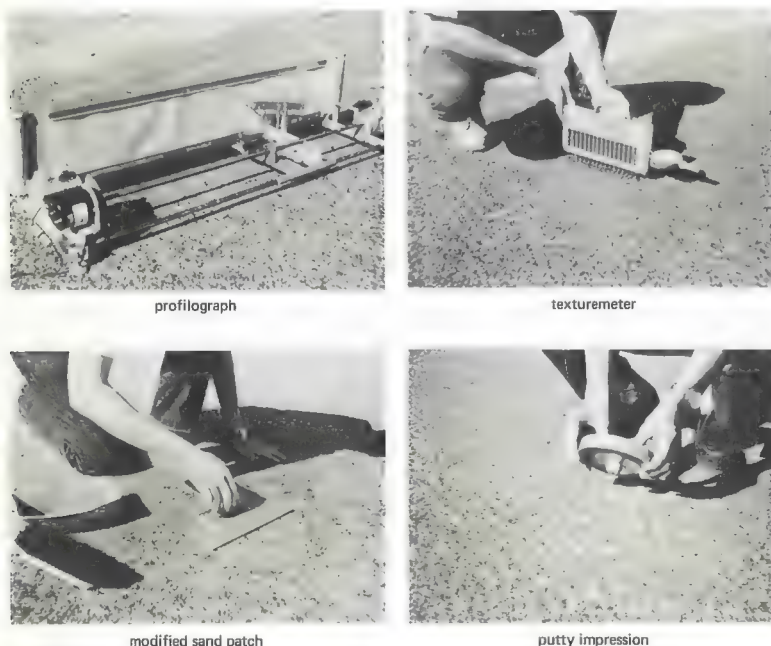
Figure 3. Equipment used for macrotexture tests.

Profilograph—The instrument used for this test was developed by the Texas Highway Department (15). It is designed to scribe a magnified profile of the surface texture as a probe is drawn across the surface. That is, the probe is placed on the pavement

surface and, as the probe is drawn over the surface irregularities, the vertical movement of the probe is magnified through a linkage system. The probe and linkage system are attached to a carriage that is forced to move in a horizontal manner parallel to the pavement surface by a framework with adjustable legs. The vertical and horizontal movement results in a duplicated (but magnified) texture profile that is scribed on a chart. Average peak height can then be determined. Also, the upward vertical excursions are recorded on a counter of which the counter reading, at any time, is the cumulative vertical peak heights (referenced to a median line in the surface) of the texture through the length traversed by the probe.

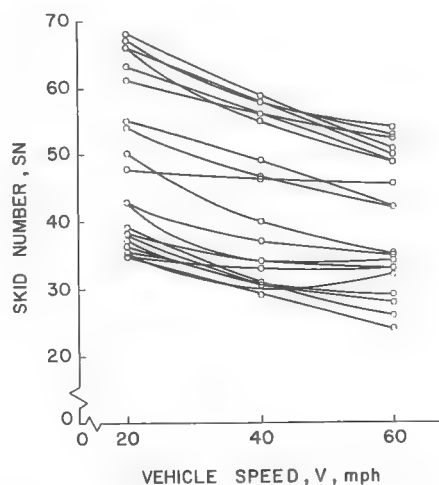
Figure 4. Skid number-speed relationships for hot-mix asphalt concrete surfaces.

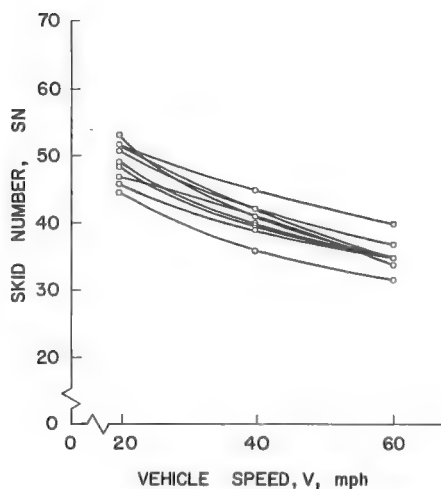
Figure 5. Skid number-speed relationships for portland cement concrete surfaces.

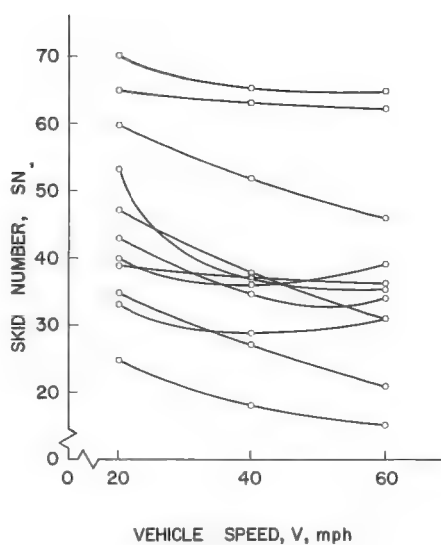
Figure 6. Skid number-speed relationships for surface treatments and seal coats.

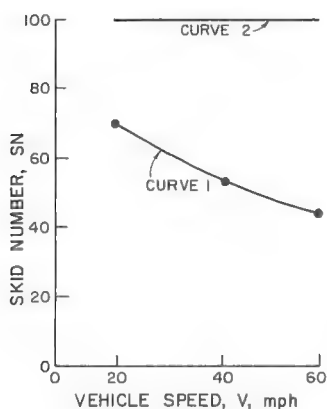
$$\text{AVERAGE SKID NUMBER } A_V SN = \frac{\text{AREA UNDER CURVE 1 (A}_1\text{)}}{\text{AREA UNDER CURVE 2 (A}_2\text{)}} \times 100$$

$$A_V SN_{20-60} \approx SN_{40}$$

Figure 7. Average skid number calculation.

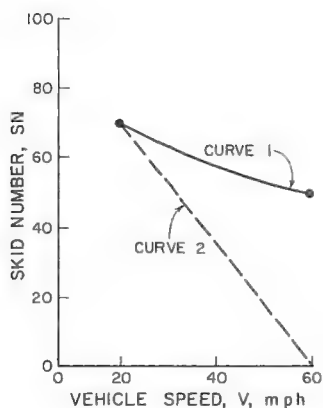
$$\text{GRADIENT (G)} = \frac{SN_{20} - SN_{60}}{40}$$

$$\text{GRADIENT (G}_2\text{)} = \frac{SN_{20} - 0}{40}$$

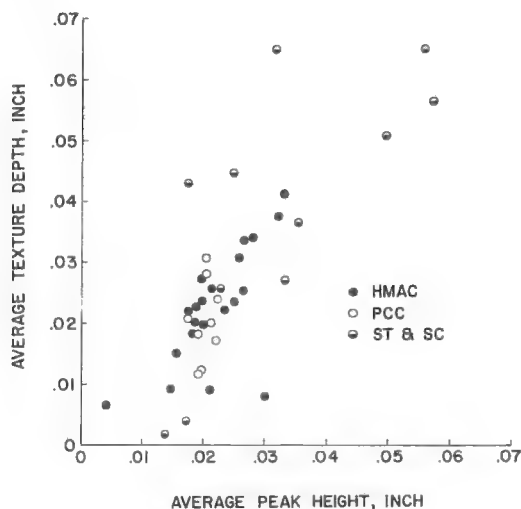
Figure 9. Putty impression versus profilograph methods.

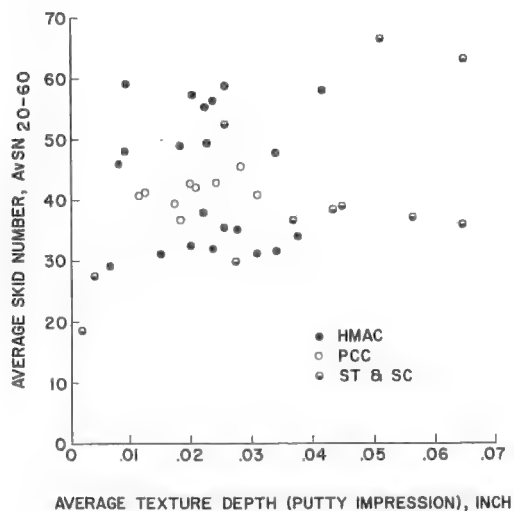
Figure 10. Average skid number versus macrotexture.

Statistical correlation of skid numbers with macrotexture measures obtained on the 41 surfaces are given in Table 5. Correlation coefficients were extremely low for all speed levels, but the relative magnitudes increased with higher speeds. Textures obtained with the profilograph consistently correlated better with skid numbers. A typical plot of one relationship is shown in Figure 10. A slight trend is noticeable.

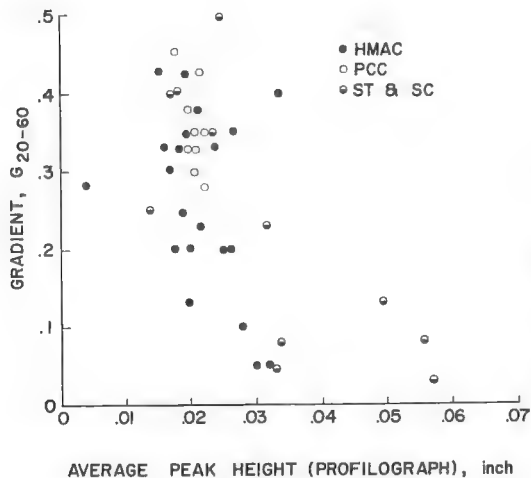
Figure 11. Gradient versus macrotexture.

Statistical correlation of friction-speed gradients obtained from 20-40 mph and from 20-60 mph with macrotexture measures obtained on the 41 surfaces are given in Table 6. Correlation coefficients were fairly low, particularly for the logarithmic relationships. Gradient computations from 20-60 mph resulted in higher coefficients than those from 20-40 mph. Also, the mechanical roughness detector instruments (profilograph and texturemeter) gave higher coefficients than the volumetric measures (putty and sand). A typical plot is shown in Figure 11.

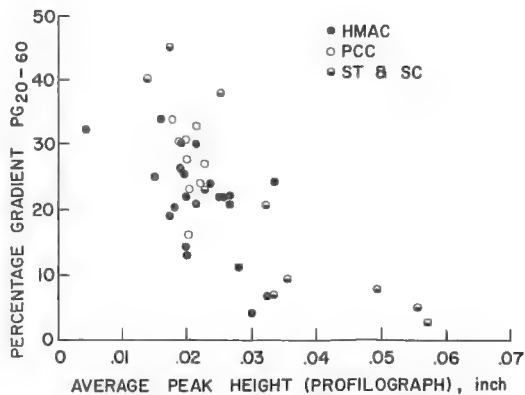
Figure 12. Percentage gradient versus macrotexture.

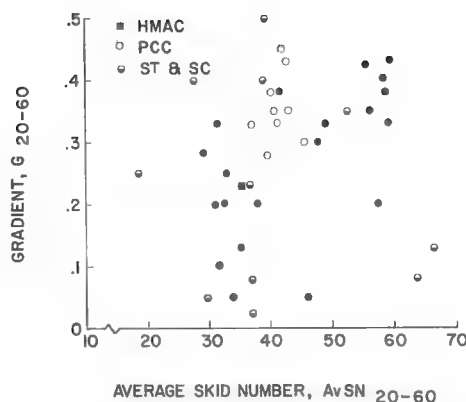
Figure 13. Gradient versus average skid number.
